Internal erosion under spillway rested on an embankment dam

Abstract

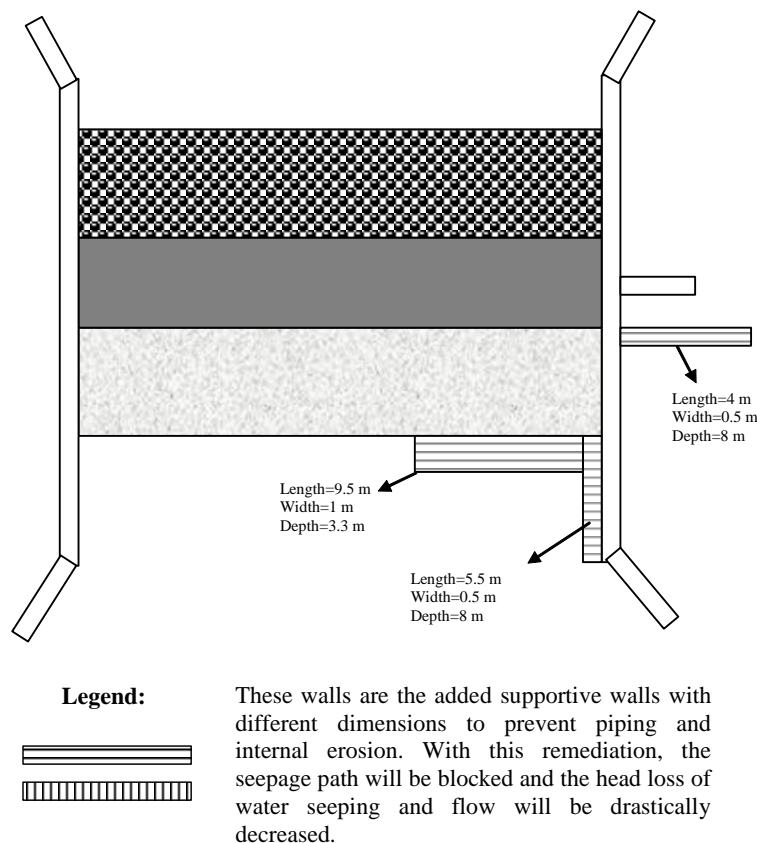
Fig. 6. Final remedial measure to protect spillway against piping in right abutment

The best case is an integrated approach to control internal erosion as well as piping. The first part is to attach a concrete wall to the main wall provided that the Lane's criterion is satisfied (Fig. 6). The second remedial action is to fill the hole pipe with concrete and cement.
